August 16, 2018

Piper Clevis Part Failure

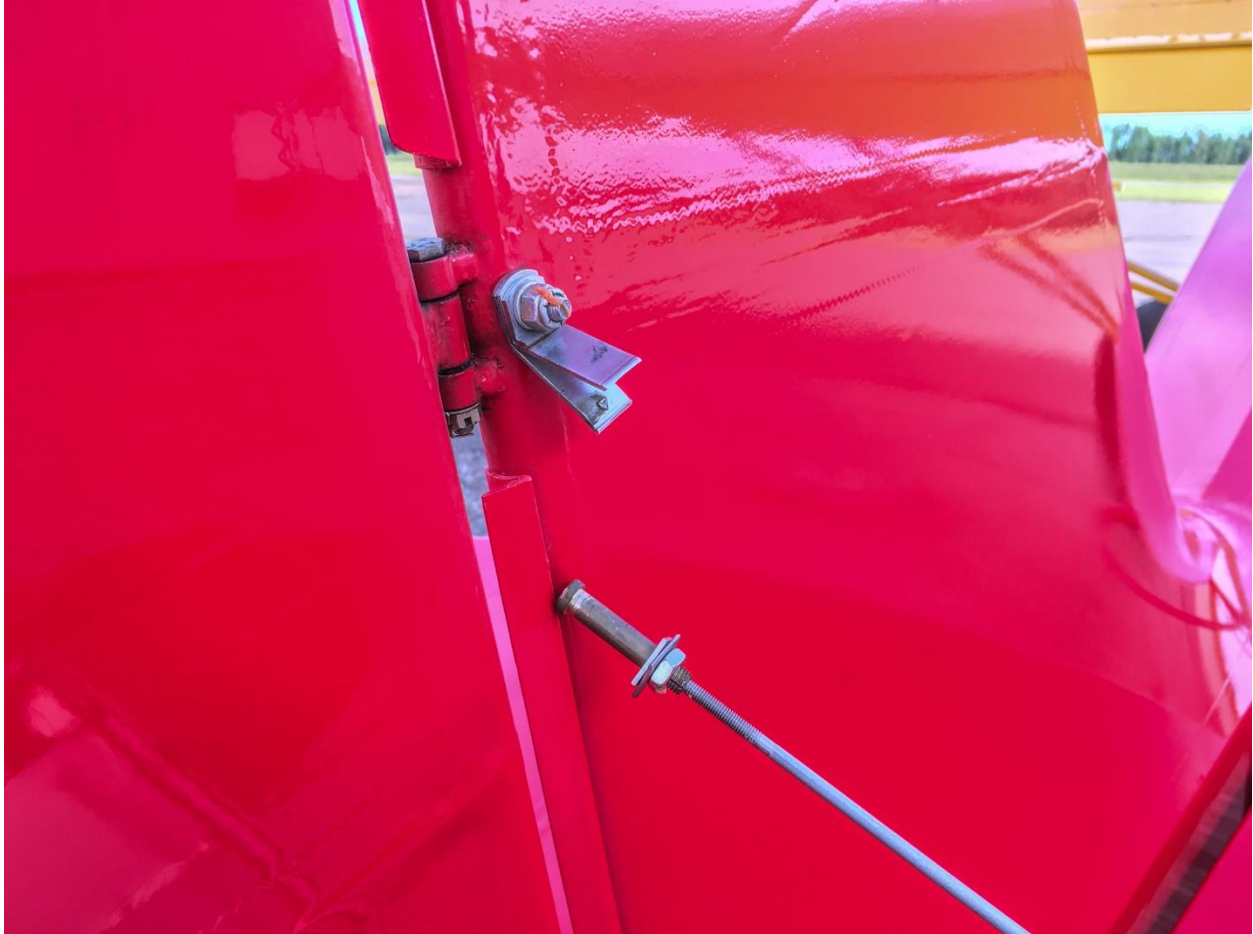
On July 7<sup>th</sup> 2018 I experience a complete break of my upper right hand Piper Clevis. Overview picture below.

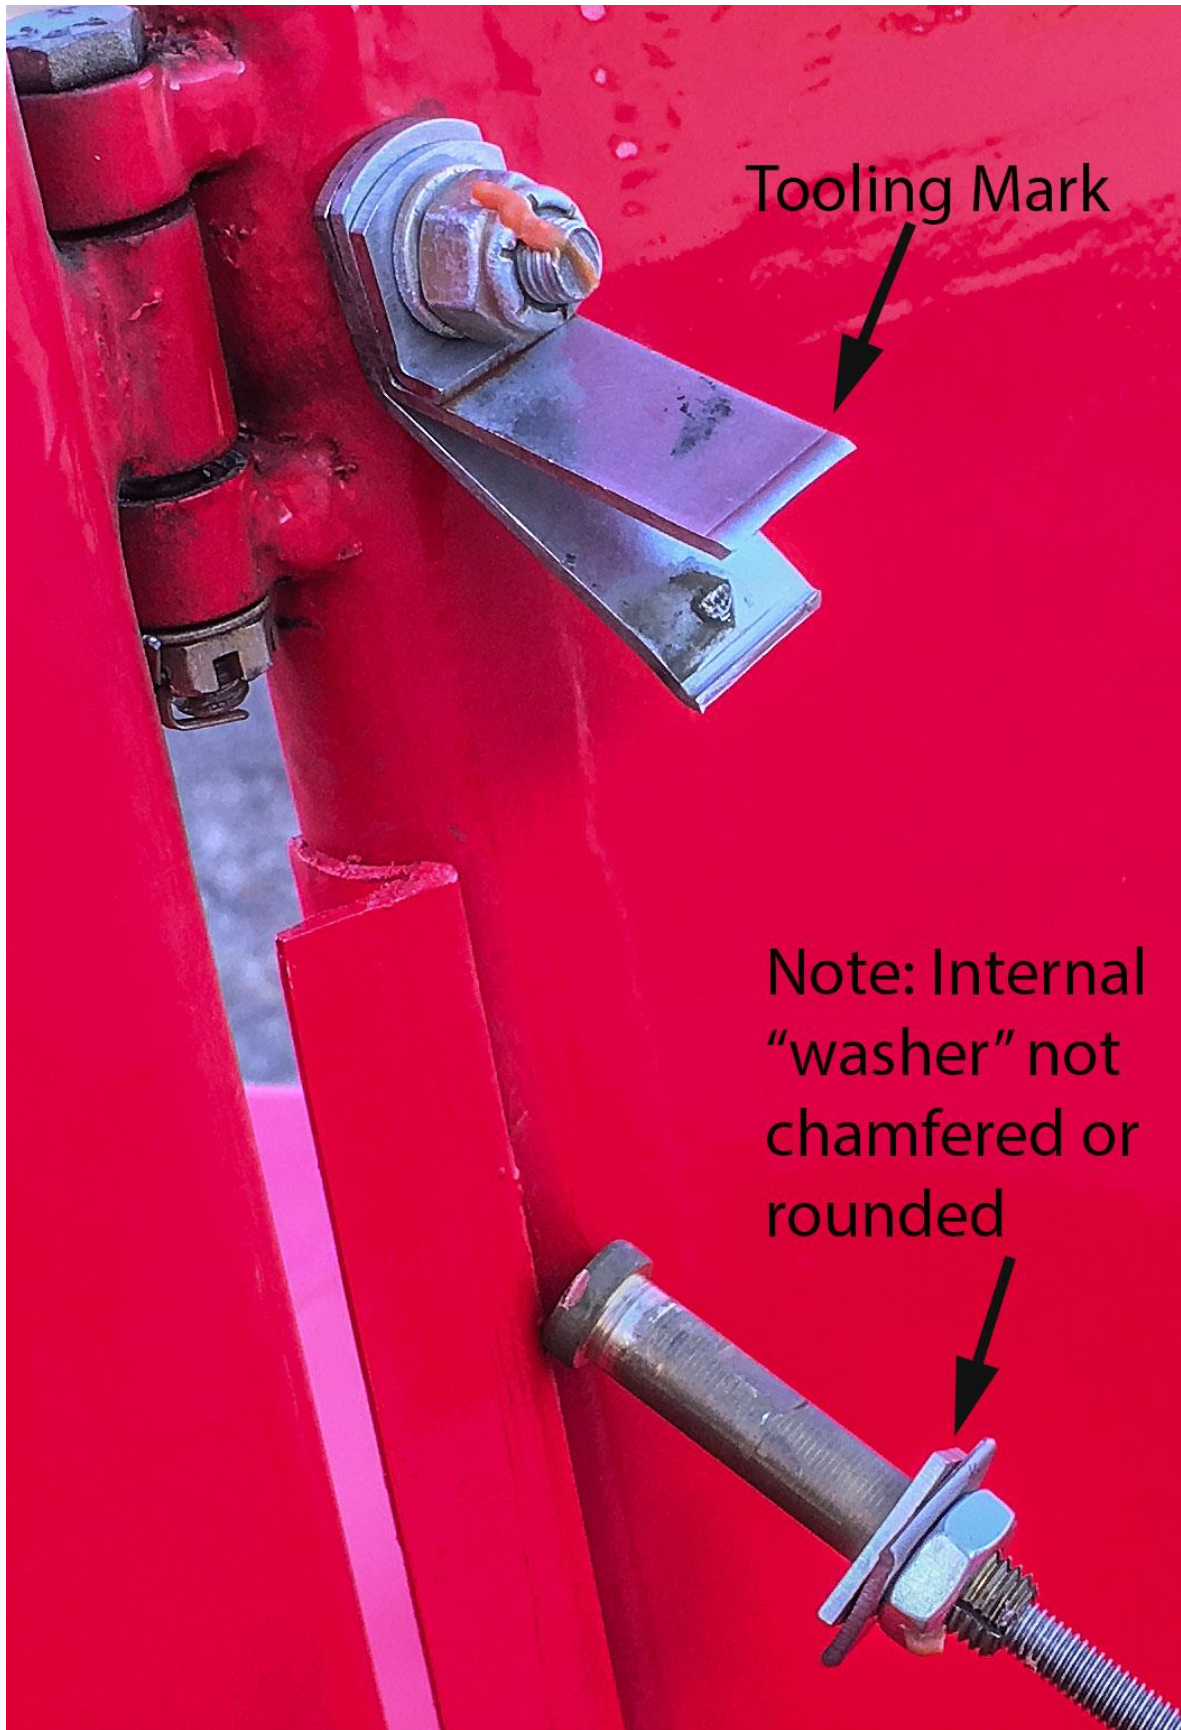
Detailed Picture of the break below:

Tooling Mark

Note: Internal  
"washer" not  
chamfered or  
rounded

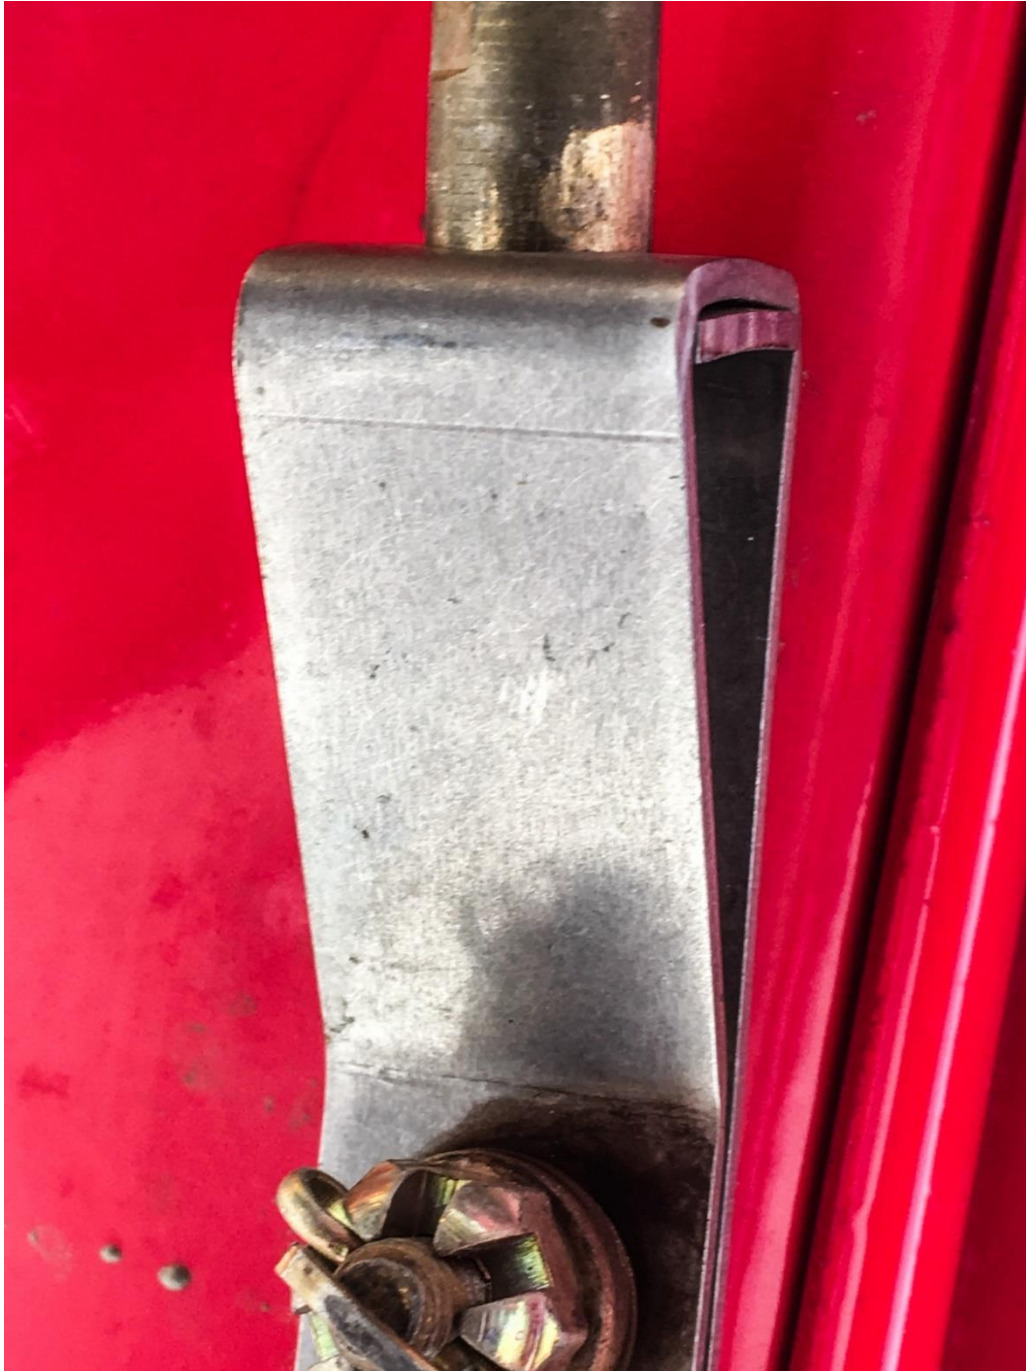
As you can see in the below image, there appear to be three issues with these brackets:

- Tooling mark, which would seem to act as a stress riser
- Possible insufficient internal bend radius
- Internal “washer” appears to not be properly chamfered (rounded) leading to a sharp edge acting against the internal bend radius, thereby increasing the likelihood of a part failure (I believe this is what caused my part failure)

I talked to Scott Ruffner and sent him numerous pictures on July 20<sup>th</sup>, 2018. Scott confirmed the presence of the tooling mark, as well as confirming that 1) He receives the Piper Clevis [part with the tooling mark] from another unspecified vendor; 2) The internal “washer” is indeed supposed to be chamfered—but all of the parts in his current (at that time) inventory were not chamfered. Scott indicated that his company parts drawing did in fact call for the internal “washer” to be chamfered, but that step was apparently skipped.
